BESS Quality Risks

A summary of the most common Battery Energy Storage System manufacturing defects

February 2024

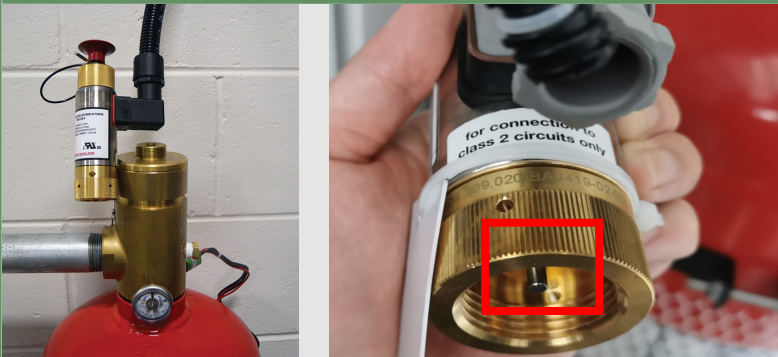
Non-responding release actuator for the fire extinguishing agent

A diode within the actuator was faulty.

A malfunctioning actuator will not respond to the command of releasing a fire extinguishing agent, potentially allowing the fire to further propagate.

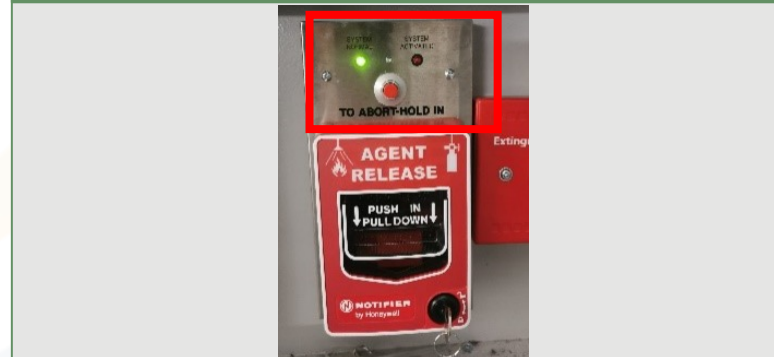
Fire alarm abort button was not functional

The fire alarm abort button was not responding to the user commands due to incorrect wiring.

The abort button allows user to deactivate an improperly triggered fire alarm; failure to deactivate can lead to unwanted fire extinguishing agent or sprinkler system activation which can cause serious damage to equipment.

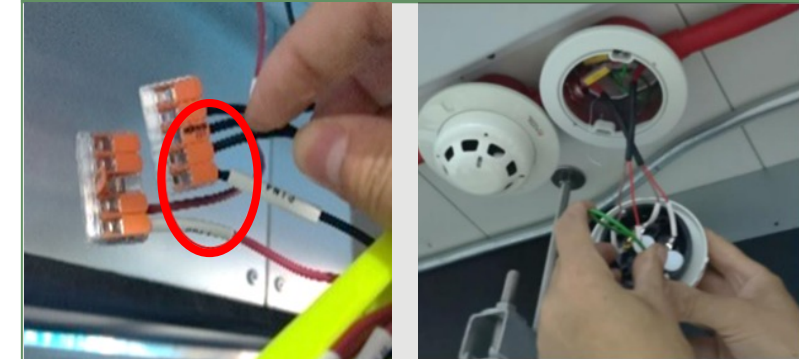
Non-responding smoke & temperature sensors

The smoke sensor was incorrectly wired, and a temperature sensor was reversely connected to power source.

An incorrectly wired smoke sensor cannot detect the presence of smoke within the system. A reversely connected temperature sensor can have a false reading. Malfunctioning of these sensors can pose a high fire and explosion risk.

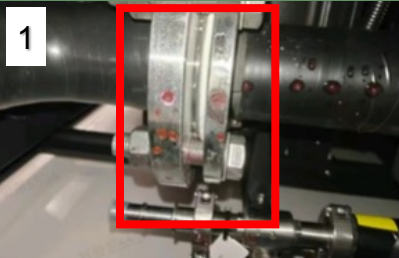
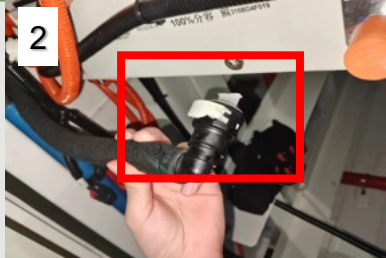
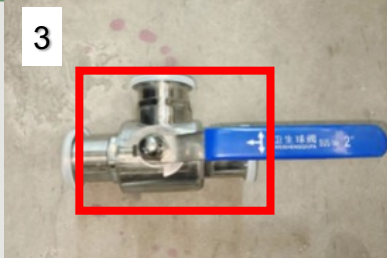
Circulation System Components Failure

Why/How Does It Happen		
1. Flange plates are deformed from overtightening due to a loosely defined screw mounting Standard Operating Procedure (SOP).	2. Loose pipe connection: the fastener was not fastened from operator's mis-installation and not following SOP.	3. Defective incoming material: the valve comes with a loose stem.
Risk		
1. Internal short circuiting and thermal runaway initiation from continuous coolant leakage.	2. Severe short-circuiting events and thermal runaway initiation from potential massive coolant leakage.	3. Faster battery degradation from insufficient coolant flow control and internal short circuiting and thermal runaway initiation from continuous coolant leakage.
Example

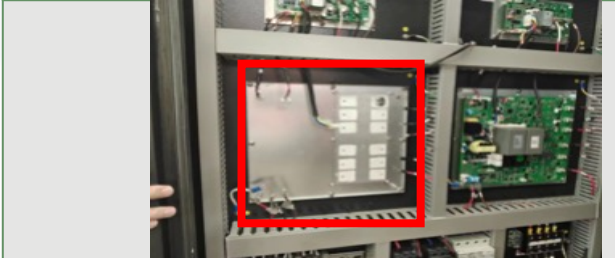
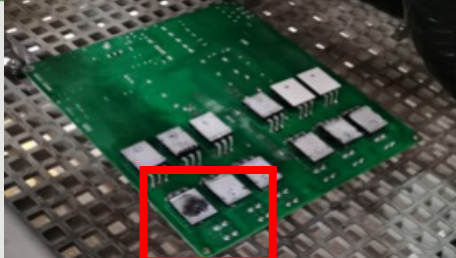
Compressor mainboard short circuiting

Why/How Does It Happen
Defective mainboard with a burned MOS (Metal Oxide Semiconductor) tube for compressor control.
Risk
<ol style="list-style-type: none"> 1. Faster battery degradation from dysfunctional liquid cooling system. 2. Initiating thermal runaway or explosion with sparking from burned components.
Example
