Solar PV Module Quality Risks

A Summary of CEA's Findings in the Field

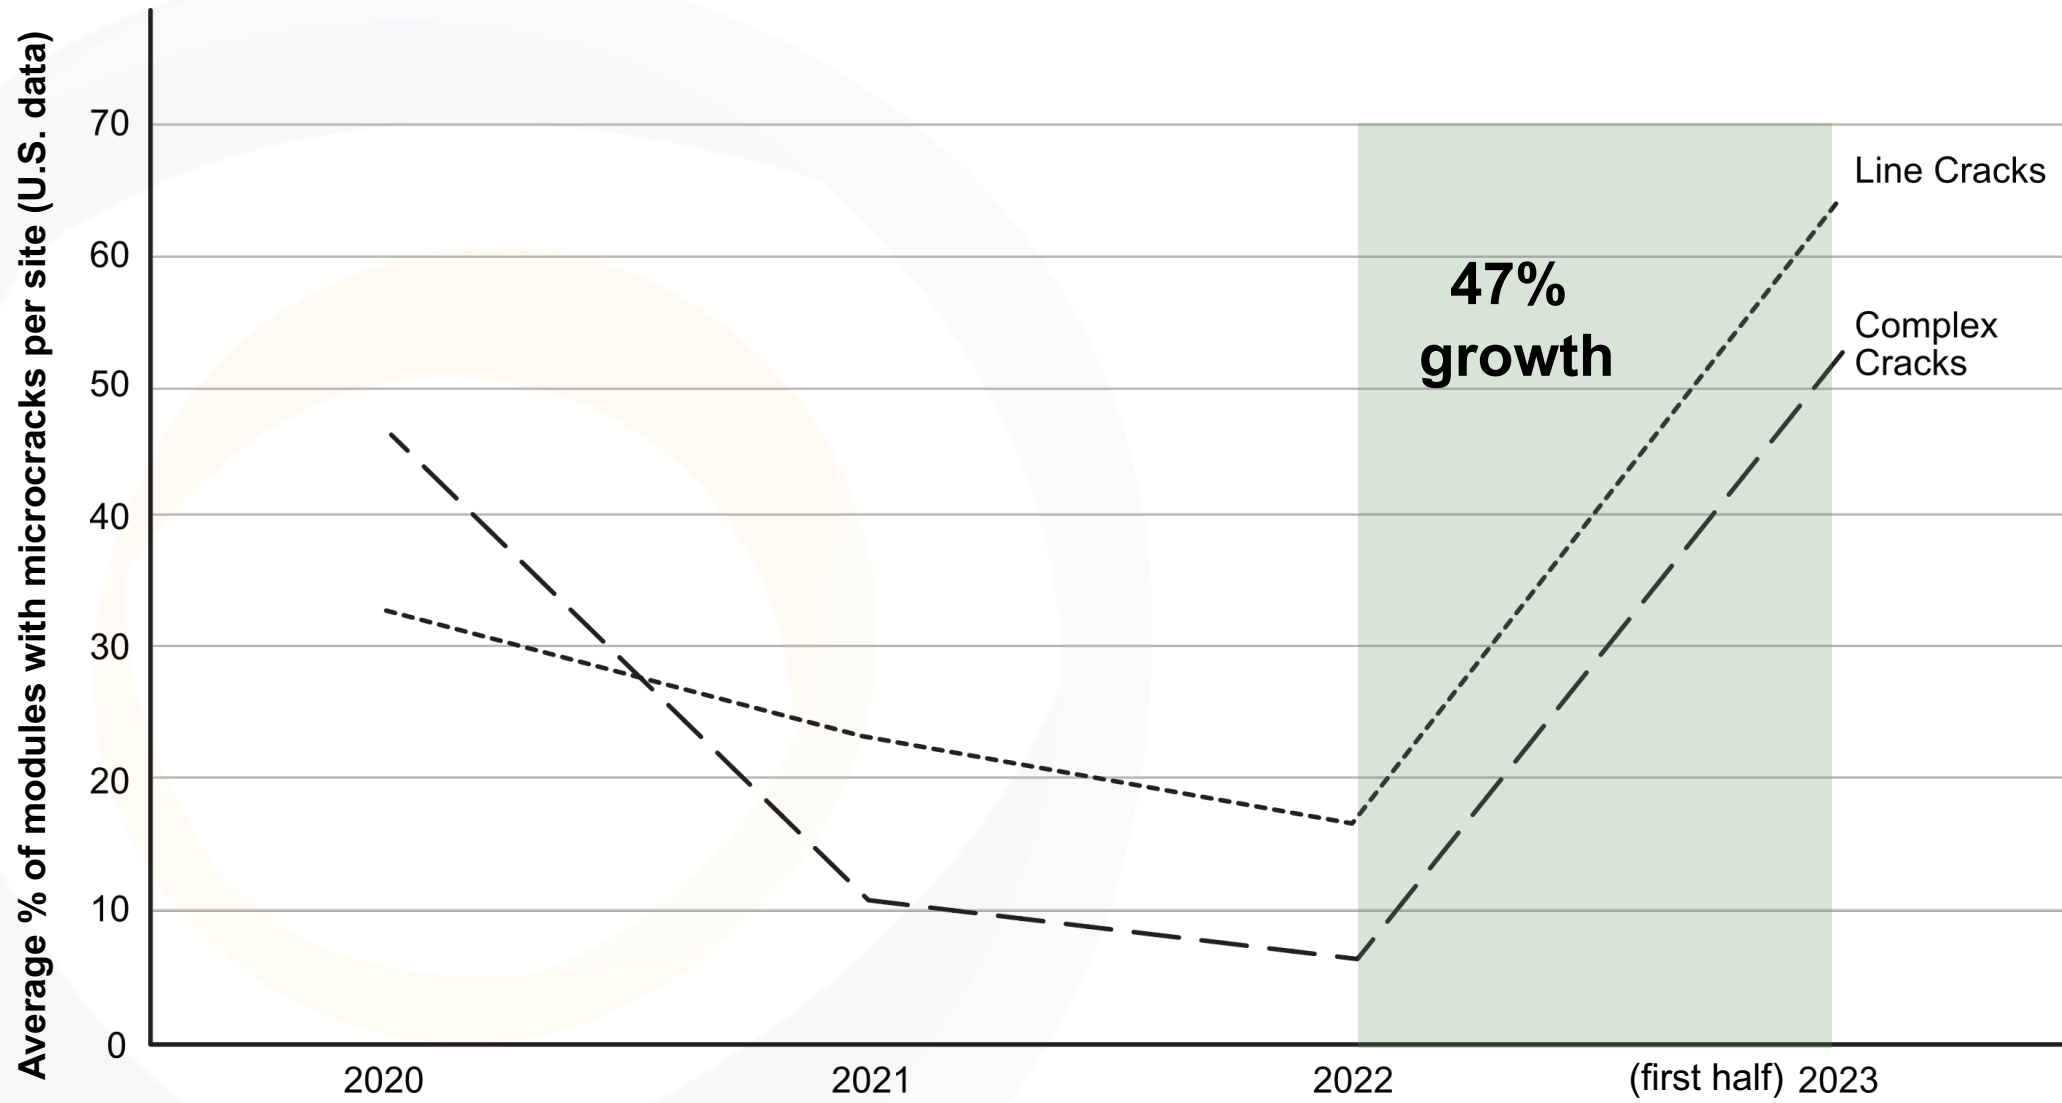
3. The Most Surprising Finding Was the Recent Massive Increase in Microcracks

83% of Sites Had **LINE CRACKS**

- 1) Wafer imperfections
- 2) Light impacts to the cell/module
- 3) Pressure on the cell during module manufacturing:
 - Stringing
 - Lamination

- 1) Increase in internal series resistance leading to minor power loss.

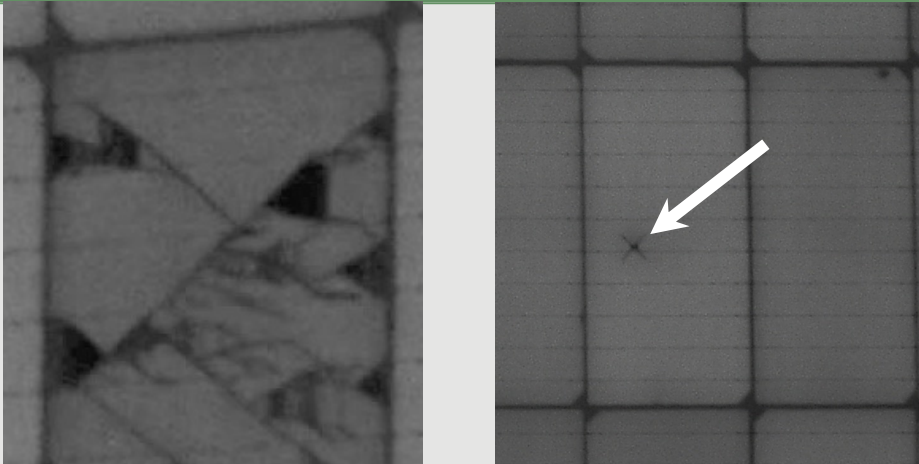
29% of Sites Had **EDGE RIBBON CRACKS**

- 1) Form where the interconnect ribbon (or wire) crosses the edge of the cell.
- 2) They often start as a tiny line or V-crack and can grow during the solar module's lifetime.
- 3) Highest risk in half-cut cells, 81% of sites with half-cut cells have this defect.

- 1) Based on CEA's experience, edge ribbon cracks are more likely to grow (compared to other microcrack types).
- 2) Impact on safety and performance (isolated areas, diode activation, hot spots).

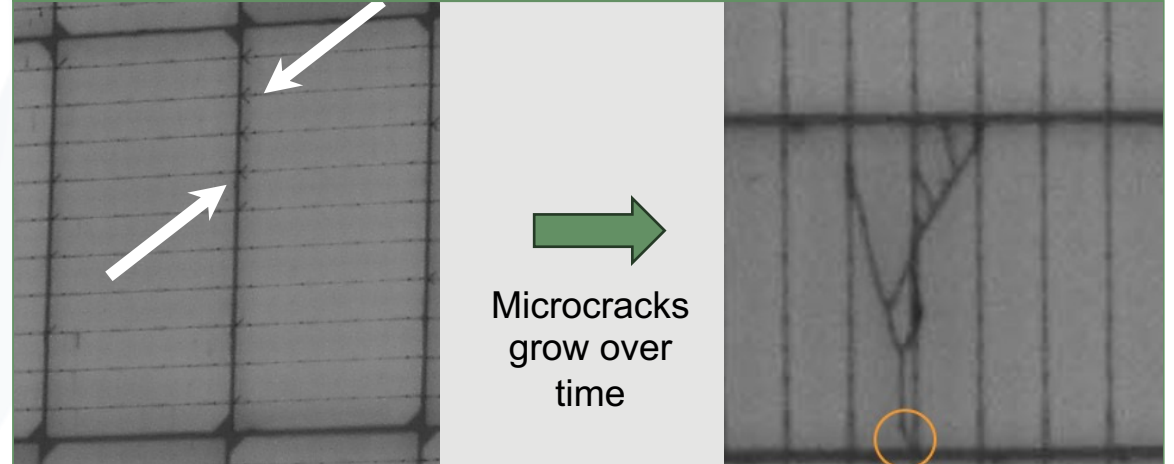
Detailed Visual Inspections Complement EL Testing By Identifying Additional Issues

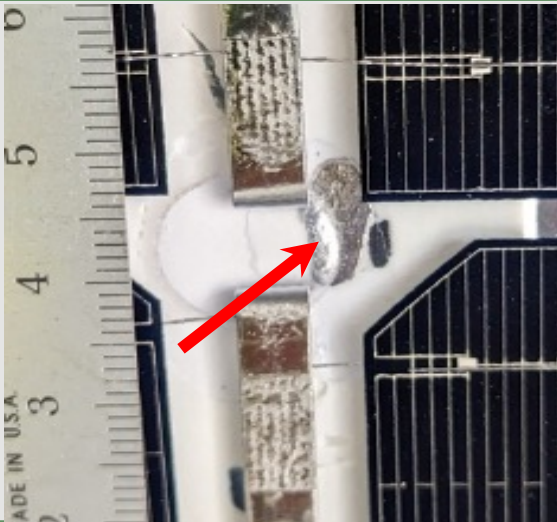
55% of Sites Had FOREIGN MATERIALS

- Unwanted substance or debris that's present within the module.
- It results from dirt, dust, debris, or other particles getting into the module during manufacturing.

- Reduced efficiency and potential degradation over time.
- May reduce internal creepage/clearance distances required for safety.

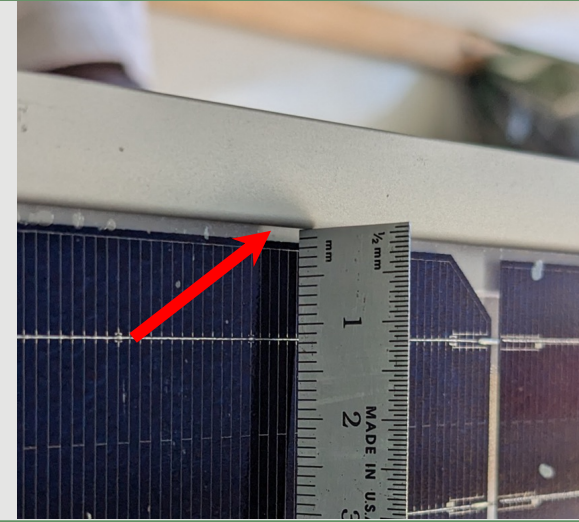
52% of Sites Had CELL TO EDGE OF GLASS DEFECTS

- The minimum distance between internal components and the edge of the glass is determined by the module design to ensure sufficient electrical insulation and to certify the module to the IEC safety standards.
- This defect can arise from manufacturing inconsistencies, misalignment during assembly.

- Internal arcing (risk of fire)

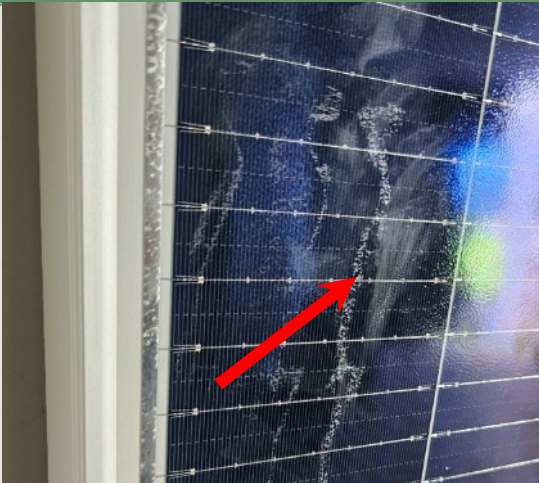
45% of Sites Had **GLASS STAINS/MARKS/ENCAPSULANT DEFECTS**

- Glass stains, marks, or encapsulant residue that cannot be cleaned off.
- Some stains/marks can occur at the site (e.g. aluminum smears), but they can also be an indicator of inadequate quality assurance at the factory.

- Can increase module soiling and decrease performance

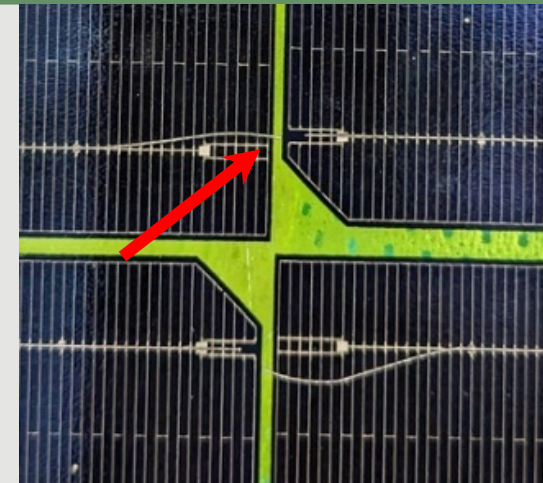
41% of Sites Had **STRINGING WIRE/RIBBON OFFPAD DEFECTS**

- An off-pad ribbon is a segment of the ribbon or string that is not connected to the solder pads, either on the cell or on the bussing ribbon.
- This results in an area that is not properly electrically connected to the rest of the string and may have high series resistance.

- Performance loss
- Risk of hot spot development (severe cases)

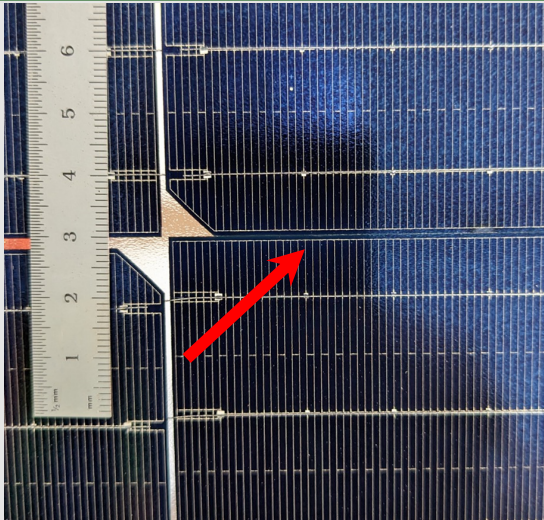
41% of Sites Had **CELL to CELL DEFECTS**

- Cell to cell defects refer to misalignment affecting the distance between cells
- These defects can arise from manufacturing inconsistencies, misalignment during assembly

- Reduced efficiency and hot spot development

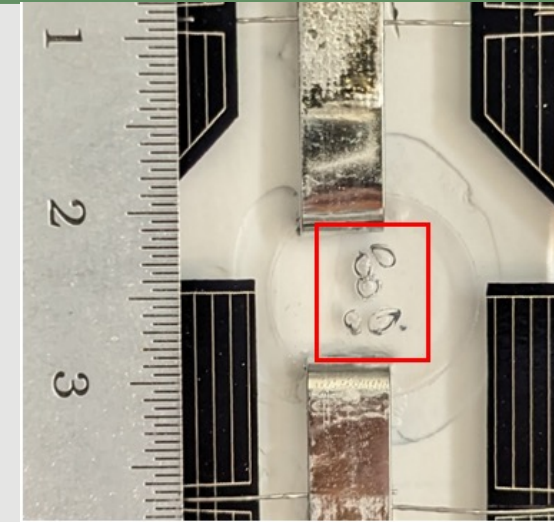
41% of Sites Had **LAMINATE BUBBLES**

- Voids or bubbles are small pockets of air or gaps trapped within the layers of the solar module.
- They can form during the manufacturing process if the layers of the module don't bond together perfectly.

- Reduced efficiency and weakening of the modules.
- Depending on location, internal short circuit and risk of fire
