## CASE STUDY

# RECORD BREAKING ON-SITE EL IMAGING TEST IDENTIFIES CAUSES OF SIX FIGURE LOSSES FOR MAJOR O&M

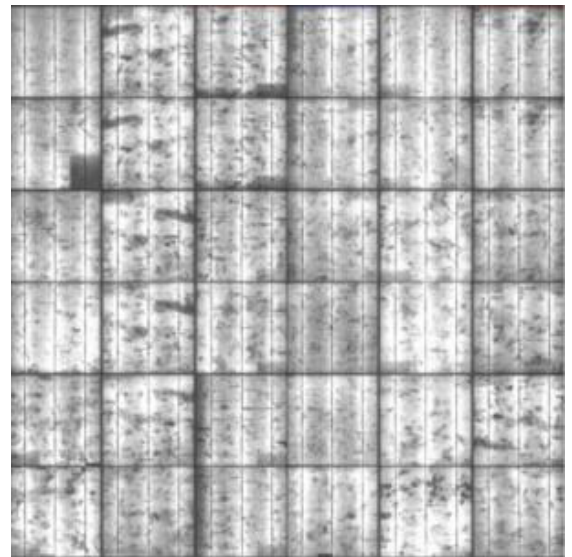
*Defect Type 1: A cell with all grid fingers not connected between bus bars.*

**RECOMMENDATION:** CEA recommended the O&M provider prioritize the replacement of modules with Type 1 defects as they were the main cause of the reduced power output. The less urgent replacement of modules with Type 2 defects was also recommended. Additionally, CEA informed the client a significant number of modules had failures in their bypass diodes.

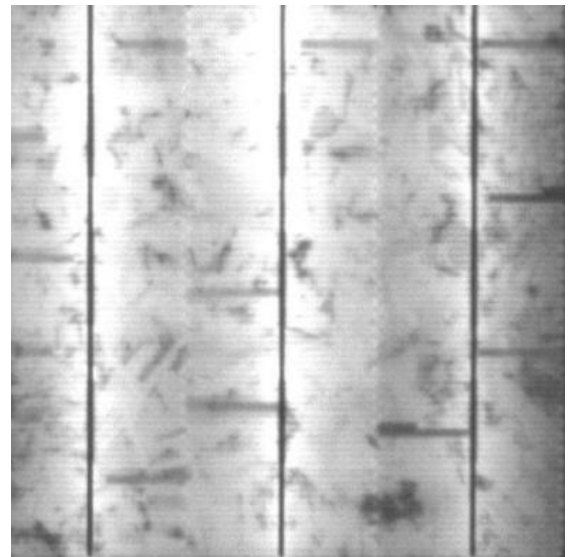
*Defect Type 2: Modules with cracked cells and cells with microcracks.*
