CASE STUDY

COULD 20% OF YOUR RECEIVED MODULES BE AFFECTED BY DETRIMENTAL MICROCRACKS?

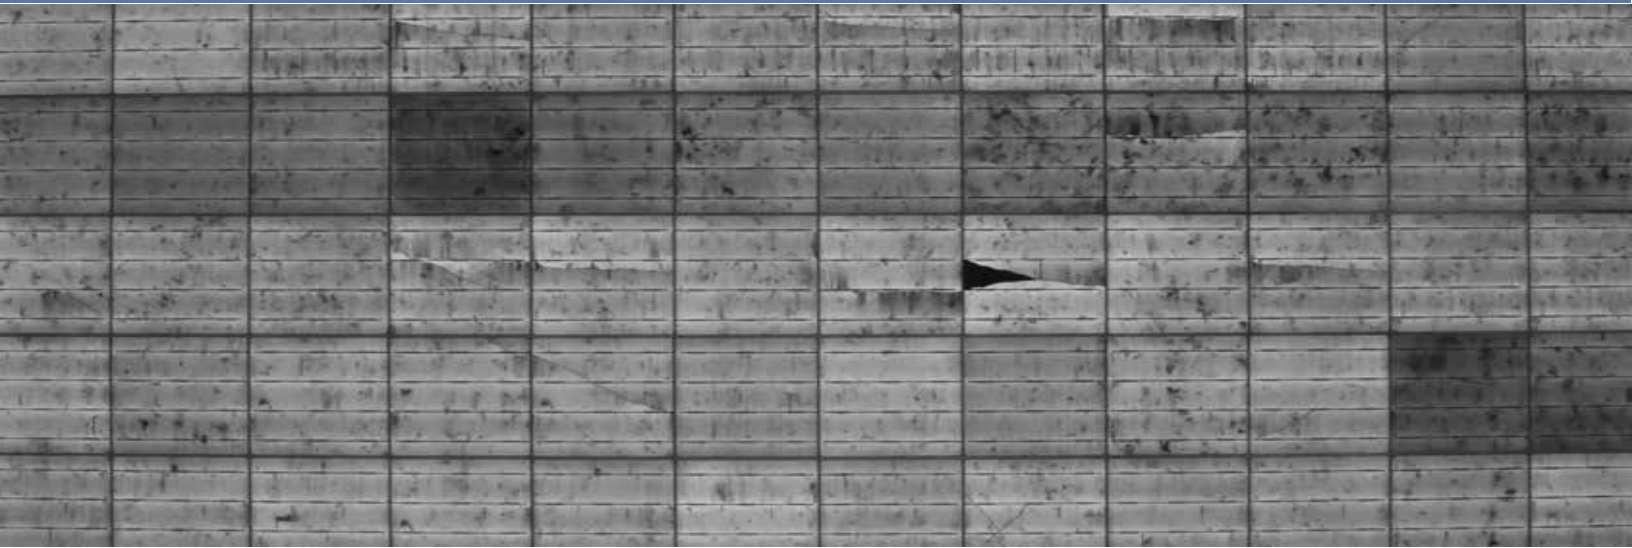
CEA conducted visual and EL testing on a sampling of 500 modules and found 29% of the modules to be defective per the manufacturer EL inspection criteria. Electro Luminescence (EL) testing is similar to an X-ray for the module. CEA also compared the EL images of the defective modules with the EL images taken at the factory pre-shipment. It was found that 36% of the defective modules (10.5% of the total modules inspected) were defective. The rest are assumed to have been damaged during packaging at the factory, during shipping, or while in the warehouse in the US. There are several key takeaways from this finding. First, **the high rate of defects present in the modules before shipment emphasizes the need for quality assurance inspections during module manufacturing, especially for less established manufacturers.** Second, the majority of the defects observed, occurred after the factory EL images were taken. **This emphasizes the value of conducting a post-shipment inspection and the need for attention to the shipping and handling conditions of purchased modules.**

CEA determined that the entire batch of modules could not be installed without significant risk to system performance. Microcracks have the potential to develop into a loss of active area and reduce the output of not only the modules containing microcracks but the entire strings containing a defective module. Over time microcracks can lead to diode activation or hot spots that represent a safety risk. Therefore, CEA recommended efforts to remove the defective modules.
